Paiko Peninsula

Table 33 - Paiko Peninsula. Changes in the Vegetation Line in Feet.

Photomap 33. Paiko Peninsula

Plate 12. Paiko Peninsula. During the 1928 to 1961 interval, Paiko Peninsula grew over 900 feet to the east (left). Since 1961, the shape of the peninsula has been modified artificially.

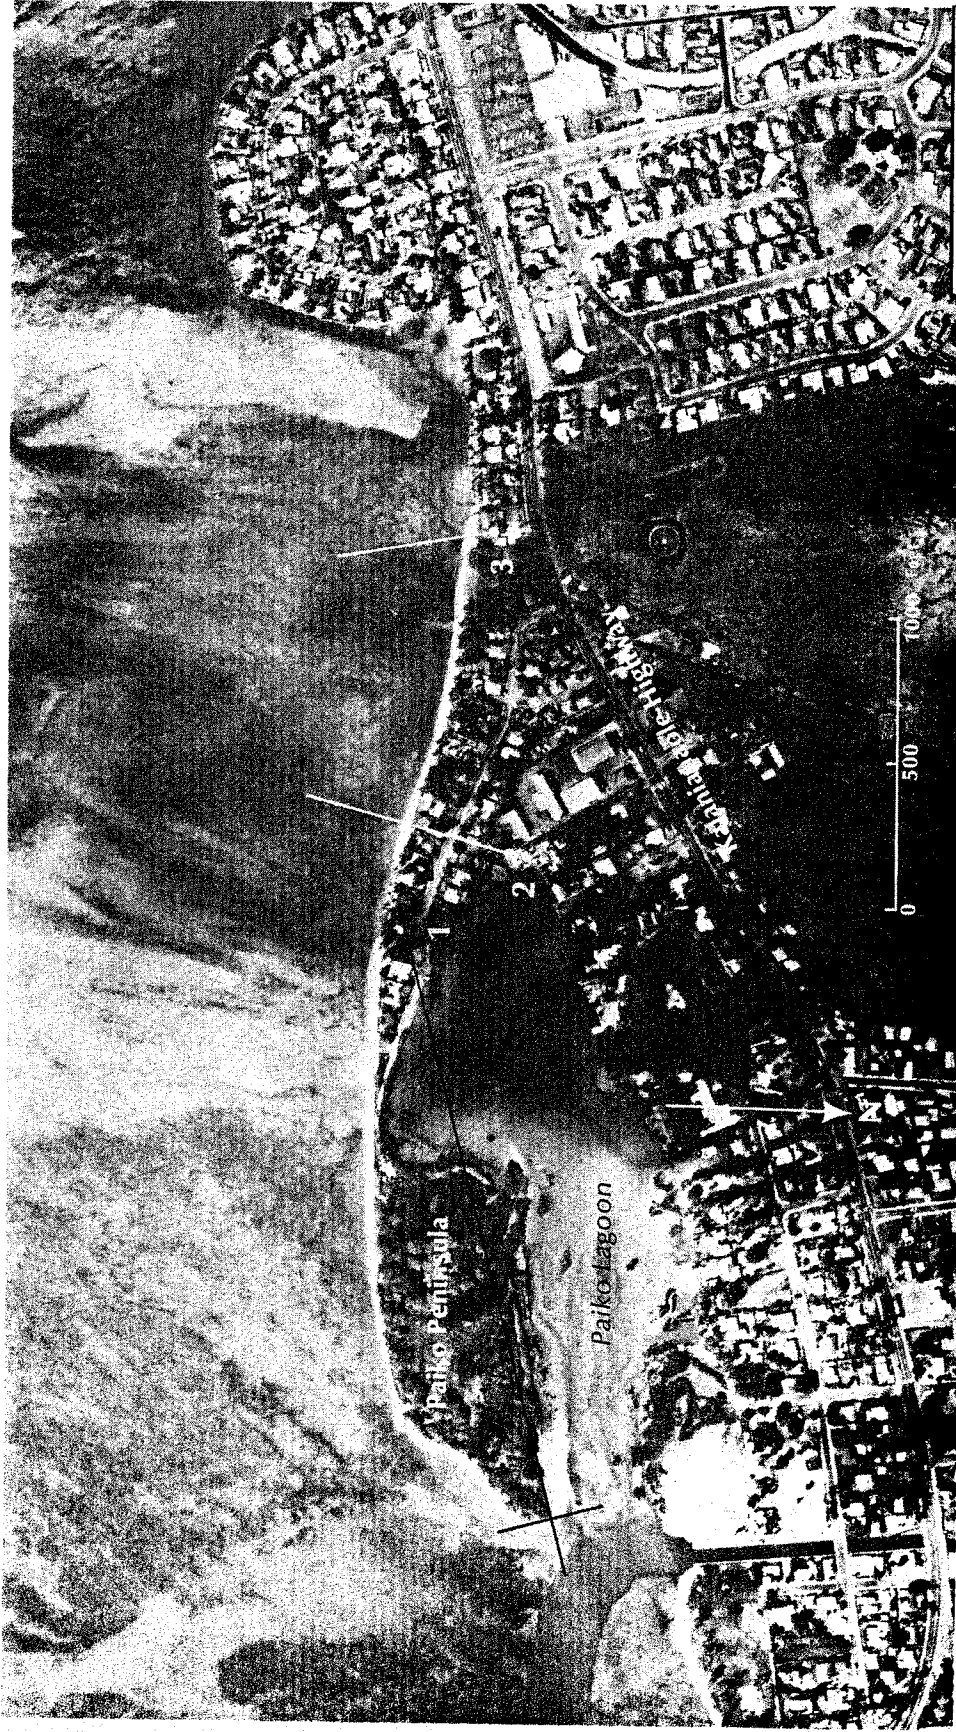
Geomorphologists would classify Paiko Peninsula as a barrier spit, an elongate sand body that extends from the coastline in a roughly parallel trend and is separated from the land by a lagoon. The peninsula changes in the following manner. Wave action transports sand from the fringing reef to the beach along two distinct sand plumes. One is located to the east of Niu Peninsula and the other is near transect 1 (Photomap 33).

Photographs by Air Survey Hawaii: January 1971

Once on the beach, the sand is carried from west to east by longshore currents. As the sand passes the tip of Paiko, two results may occur that are dependent on the relative amounts of wave energy. If the wave action is strong, sand is deposited in a fork-shaped washover fan extending into Paiko Lagoon. When the wave energy is low, the spit grows to the east.

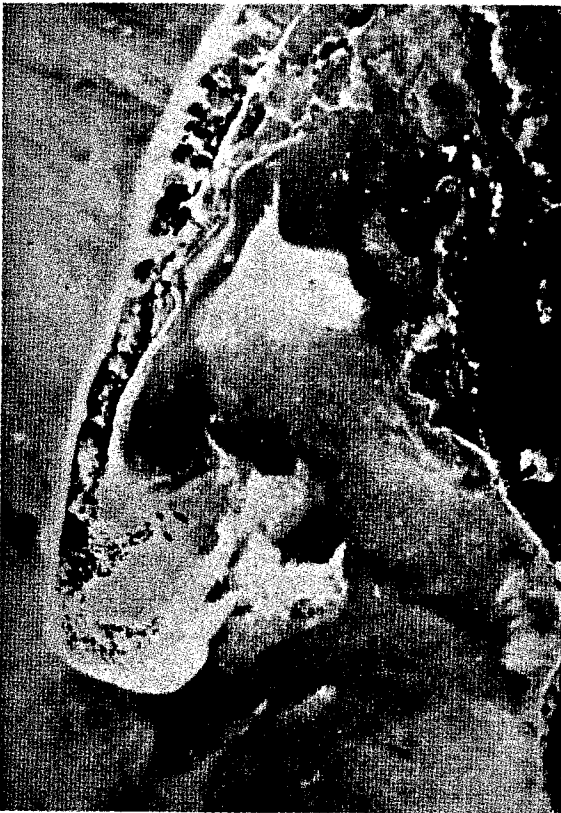
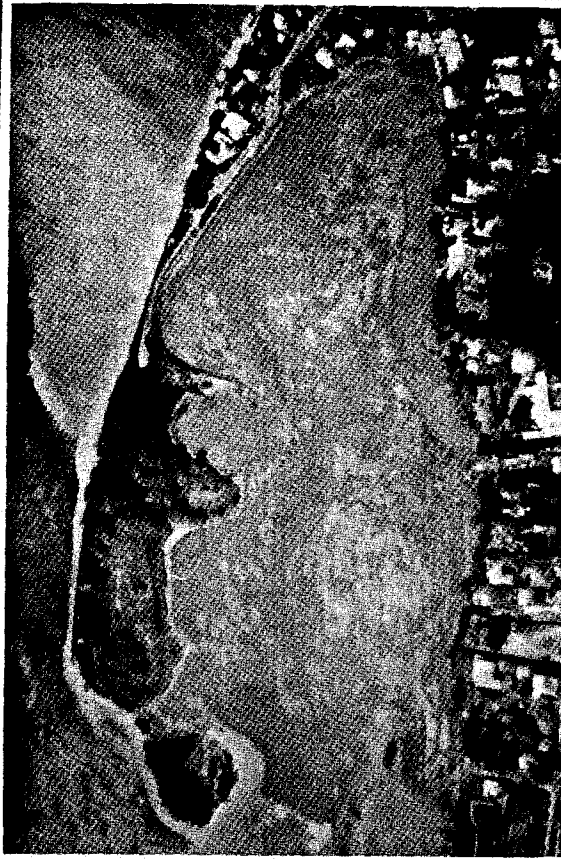
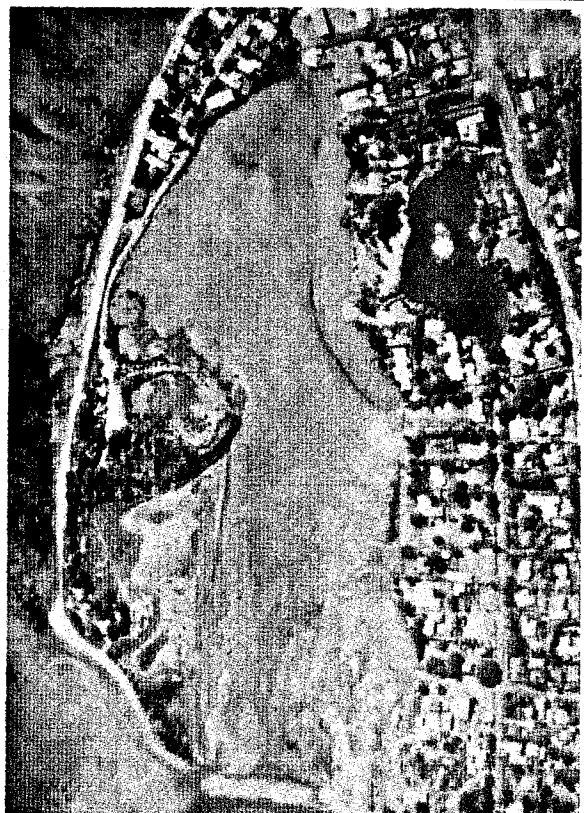
1928

1975

1961

Between 1928 and 1949, the tip of Paiko Peninsula grew eastward about 550 feet (Table 33, Plate 12). This extension to the east occurred at an average rate of over 25 feet per year. Meanwhile, the arm of the spit thinned considerably. If not for a rock wall built along the shoreline, the eastern end of the peninsula might have separated and become a barrier island.

From 1949 to 1961, Paiko Peninsula grew an additional 350 feet to the east. Since then, the shape of Paiko has been influenced by a nearby artificial channel and extensive dredging operations. In the early 1970's, several channels were dredged within Paiko Lagoon to increase water circulation. Dredged material was deposited in the lagoon to create islands for wildlife habitation.
