EVALUATION OF ANTHROPOGENIC IMPACTS ON THE FLOW OF TWO COASTAL SPRINGS IN MAUNALUA BAY, SOUTH SHORE, AHU

EVALUATION OF ANTHROPOGENIC IMPACTS ON THE FLOW OF TWO
COASTAL SPRINGS IN MAUNALUA BAY, SOUTH SHORE, O`AHU

A THESIS SUBMITTED TO
THE GLOBAL ENVIRONMENTAL SCIENCE
UNDERGRADUATE DIVISION IN PARTIAL FULFILLMENT
OF THE REQUIREMENTS FOR THE DEGREE OF

By
Joseph J. Kennedy

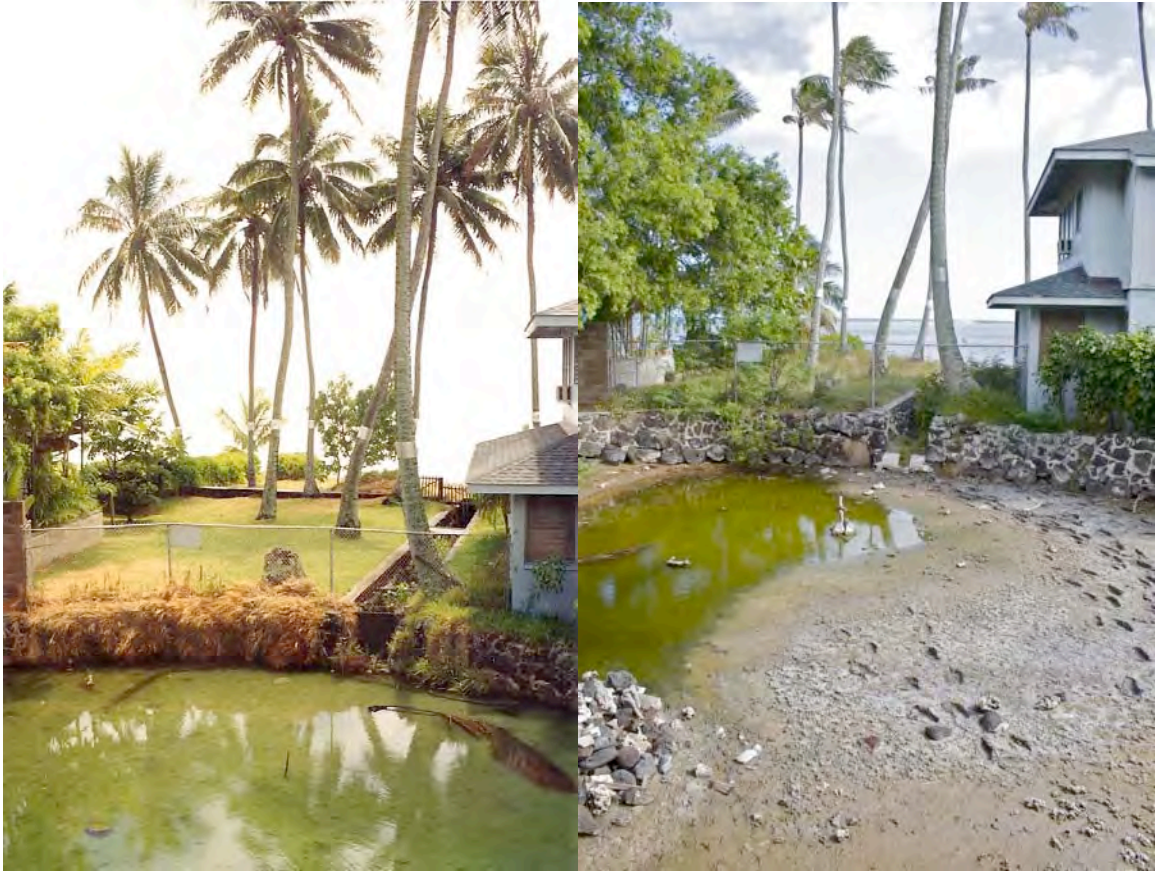
Figure 4. Lucas Spring, 1980's (Photo: T. Hara, courtesy MFHC) and in April 2010. Photo: J. Kennedy.

The nonprofit organization, Maunalua Fishpond Heritage Center (MFHC), was founded in 2006 to raise awareness about the current state of Hawaiian fishponds, with its mission to restore fishponds on the verge of being lost forever, most notably Lucas Spring, Kanewai Spring and the adjoining fishpond known as Kanewai Fishpond. The goal was in conjunction with the University of Hawai`i's Hawaiian Studies Malama `Aina Program to create a place that would allow for cultural education for the benefit of Native Hawaiians and the community. The primary endeavor for MFHC was Lucas Spring (Figure 4).

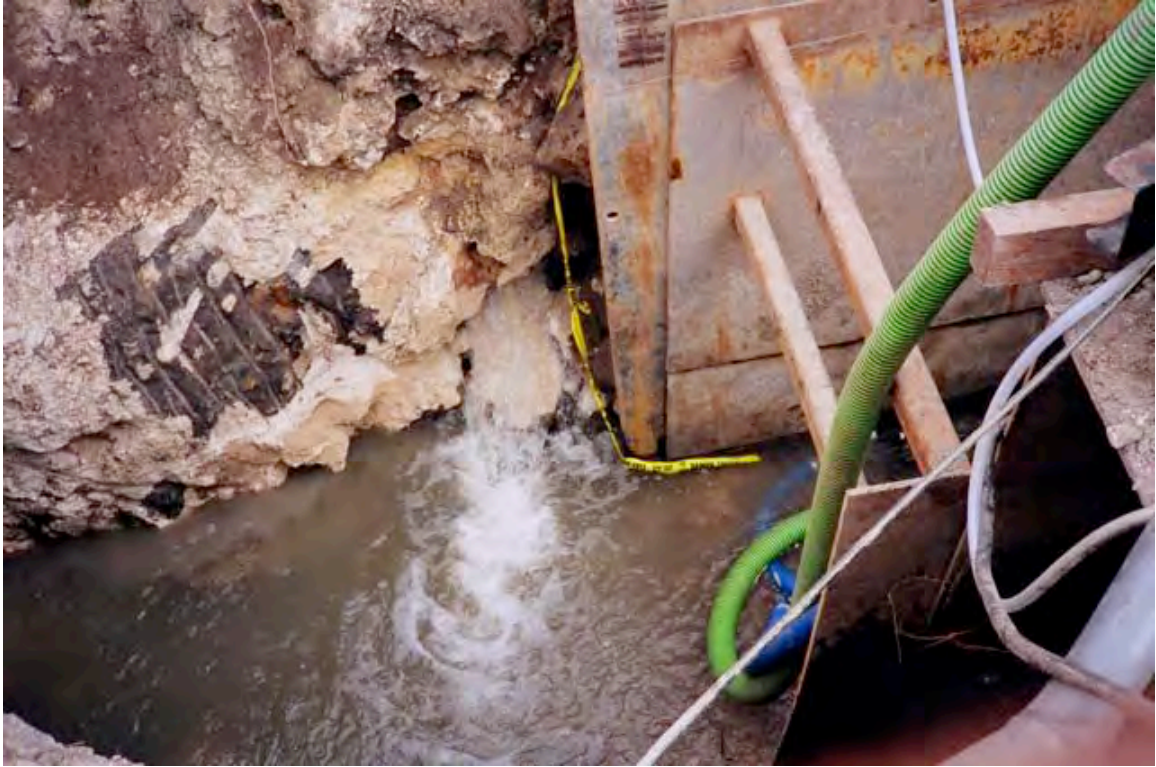
Figure 5. Water flowing out of probable broken lava tube conduit during the Kalaniana'ole Highway widening project, ca. 1993. Photo: T. Hara, courtesy MFHC.

Lucas Spring was owned and maintained by Mr. Tad Hara from the early 1970's to mid-1990's. Historical records show that an estimated 200,000 gallons (~750 m³) of water a day flowed from Lucas Spring (Stearns and Vaksvik, 1935). With this much freshwater constantly flowing into the fishpond, the water in the pond was always clear. In 1993, construction during the road-widening project of Kalaniana'ole Highway disrupted the freshwater conduit that fed the spring, flooding the utility corridors that ran alongside the highway (Figure 5, Figure 6, Figure 7). For years, speculation surrounded where the groundwater went that once flowed into Lucas Spring.

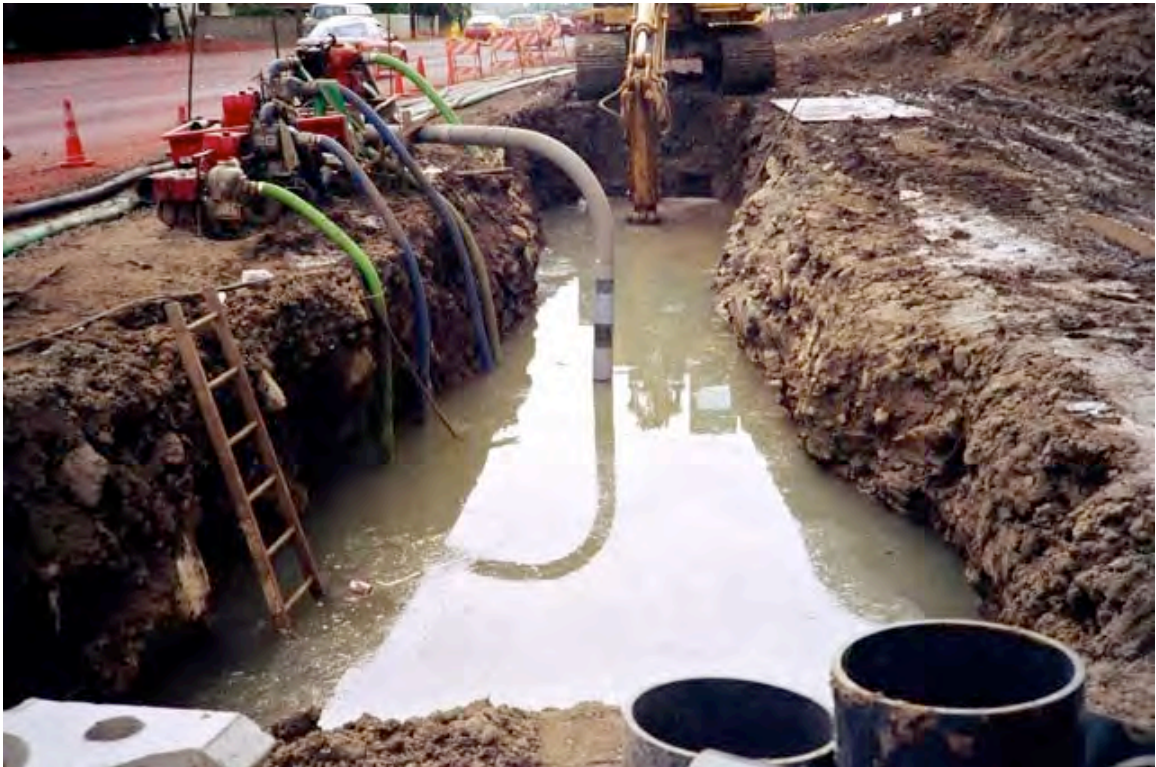
Figure 6. Water being pumped from flooded construction site landward of the Lucas Spring Study Site, ca. 1993. Photo: T. Hara, courtesy MFHC.

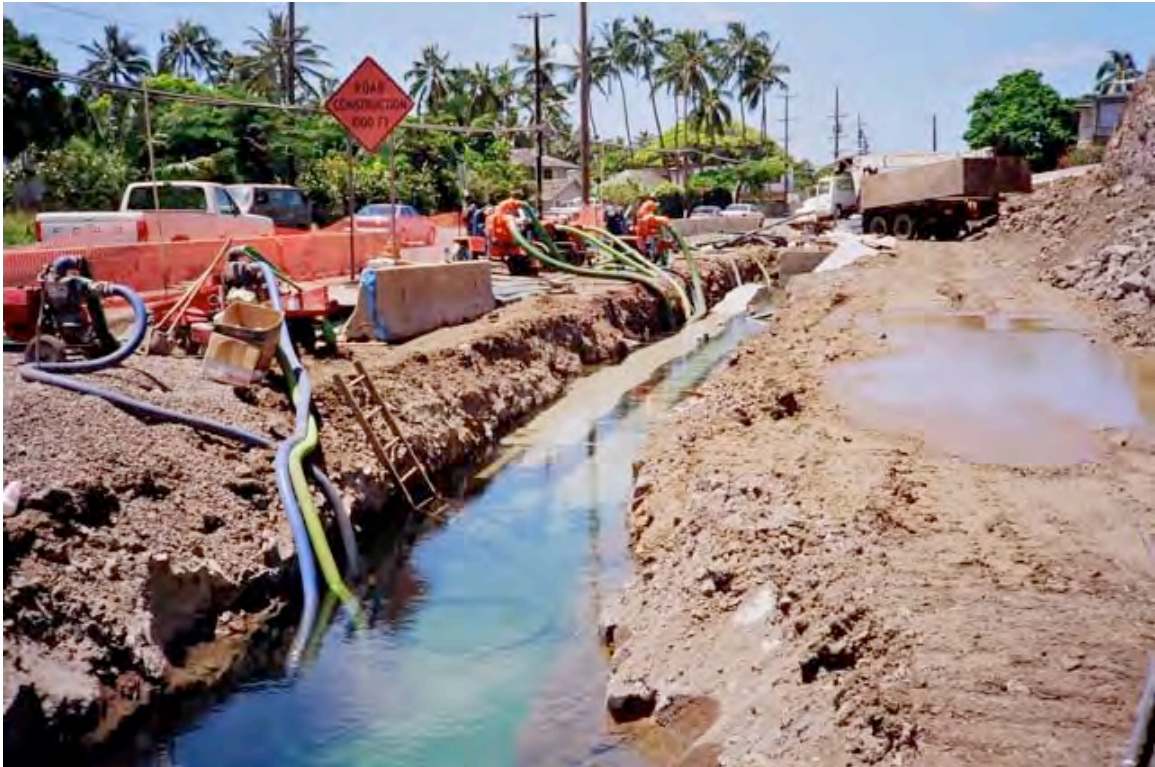
Figure 7. Water being pumped from flooded utility corridor during the Kalanianaʻole Highway widening project, ca. 1993. Photo: T. Hara, courtesy MFHC.

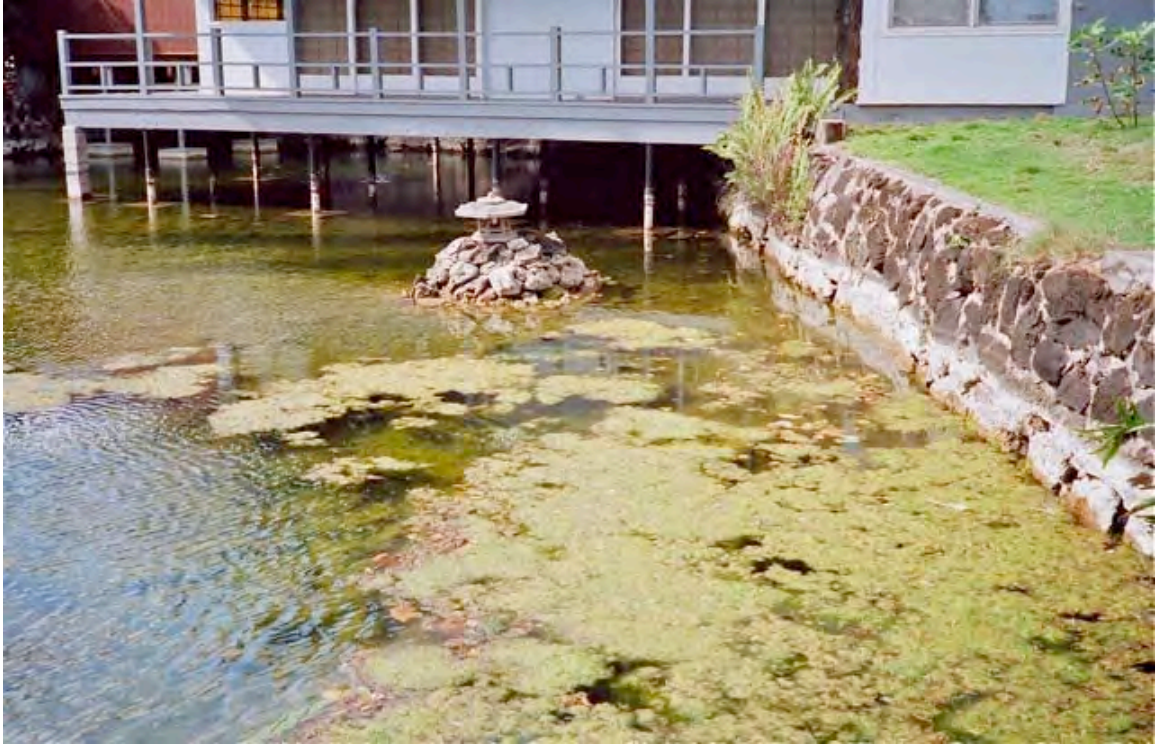
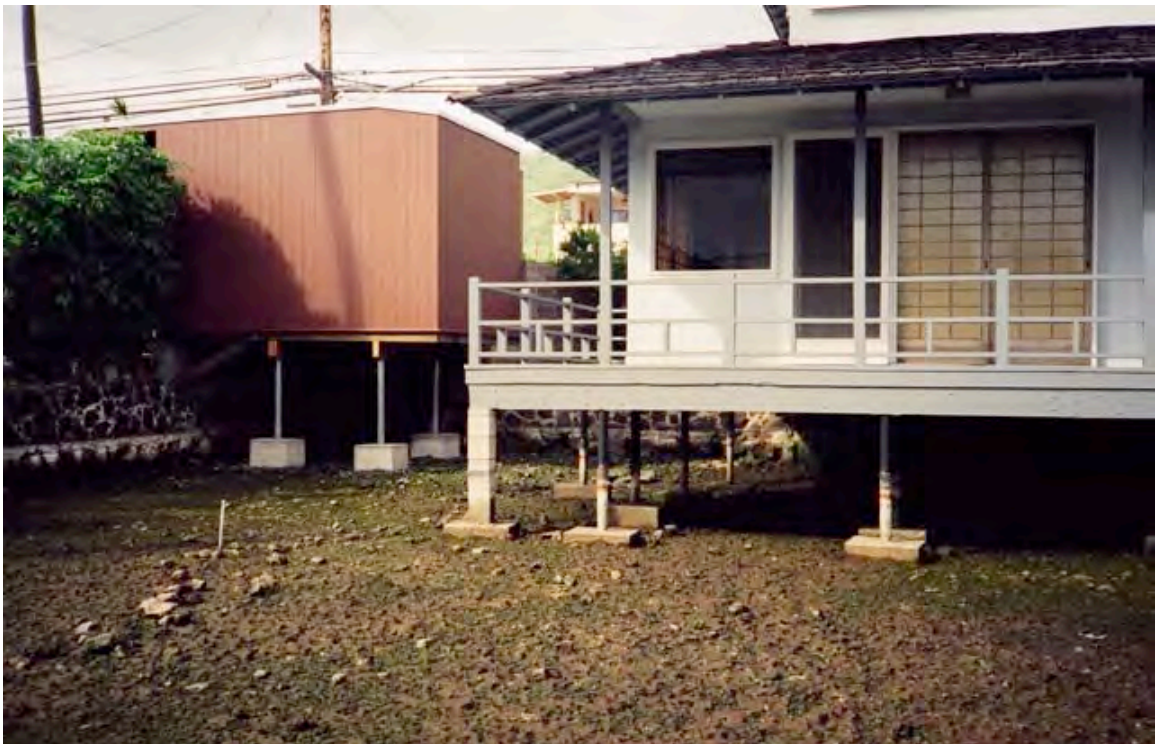
Figure 8. View of Lucas Spring after the freshwater conduit was severed and beginning to deteriorate, ca. 1993. Photo: T. Hara courtesy of MFHC.

Figure 9. View of desiccated Lucas Spring after the freshwater conduit was disrupted, ca. 1993. The T. Hara property was noted for its “house with the glass floor” which looked down into the spring-fed fishpond over which it stood. Photo: T. Hara, courtesy MFHC.

Throughout the widening project Mr. Hara photographically documented the impact the construction had on the area. His house was eventually condemned by the Hawaiʻi Department of Transportation due to the disrupted water supply and the proximity of the newly widened road to the house. With no one to take care of the fishpond and no freshwater flowing into it, Lucas Spring quickly deteriorated (Figure 8, Figure 9).

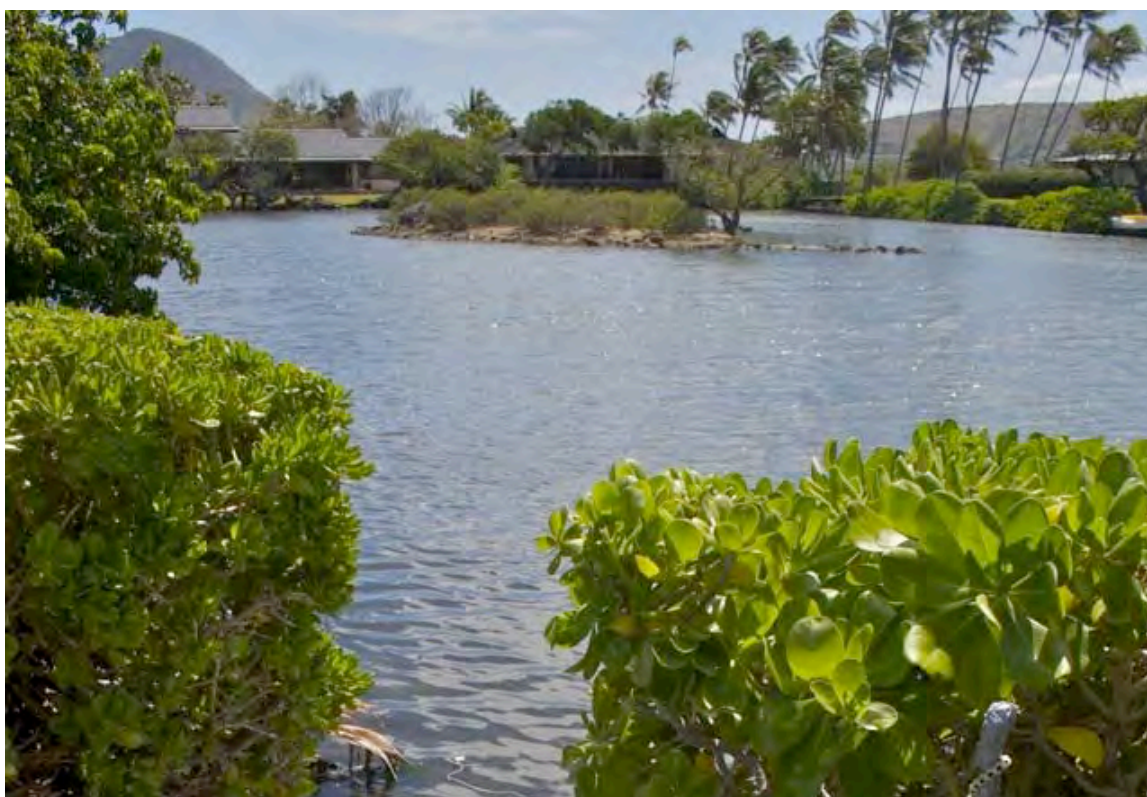
Figure 10. Kanewai Fishpond, one of the few remaining fishponds on O'ahu, April 2010. Photo: J. Kennedy

The nearby Kanewai Fishpond (Figure 10) is listed on the State of Hawai'i Historic Register as one of the last functioning shoreline fishponds in Honolulu. The fishpond's history dates back over 1000 years based on artifacts that were found in the area and it is listed as one of a few remaining royal fishponds (www.maunaloa.net). The fishpond is fed by a freshwater spring known as Kanewai Spring (one of our research locations), which is located on private property. Historic records estimate 200,000 gallons (~750 m³) of water a day once flowed from the spring (Stearns and Vaksvik, 1935).

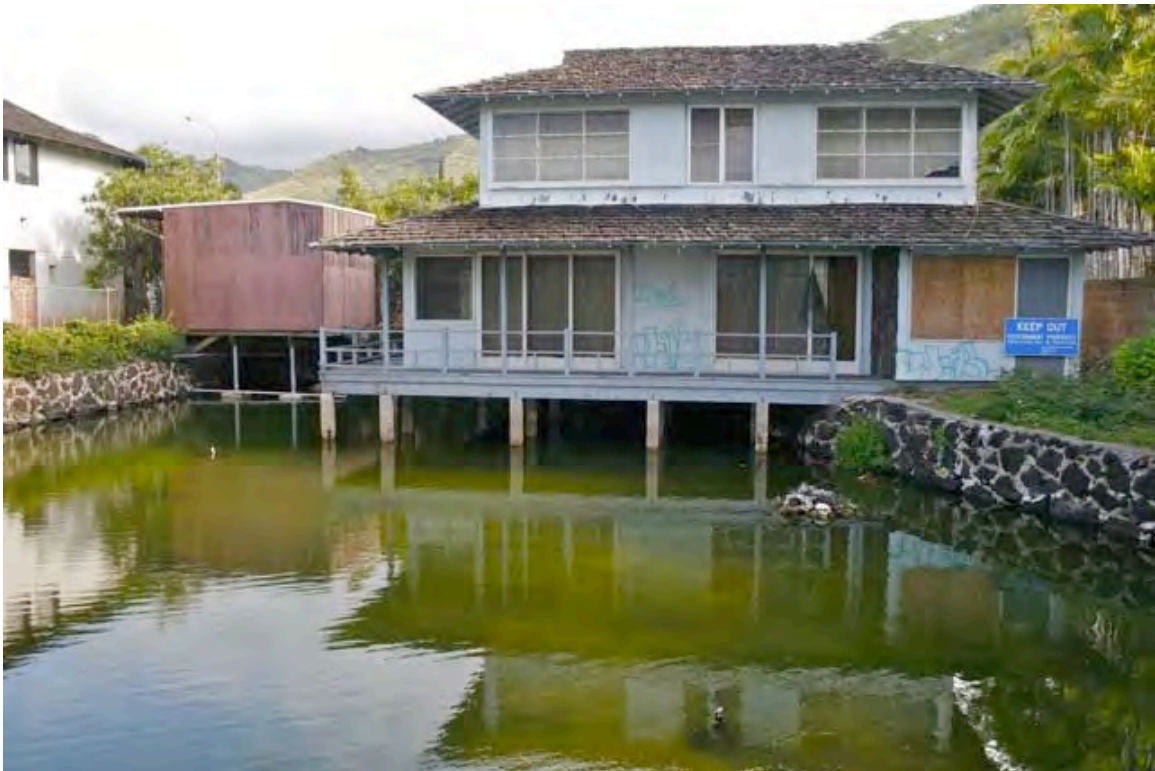
Figure 13. Lucas Spring, April 2011. Photo: J. Kennedy.

Two springs with fishponds were selected for the study of groundwater discharge. Both sites are located on the South Shore of O`ahu, Hawai`i at the terminus of the ridge that separates Niu and Kuli`ou`ou Valleys (Figure 12). Lucas Spring is located between the ocean and Kalaniana`ole Highway. The man made basalt rock walled fishpond has a surface area of 368 m². It is connected to the sea by a 0.5 m wide channel or `auwai 10 m long and is inundated by ocean water only during extreme spring tide events and intense storm swells. The `auwai was filled with sand during the entire research period. There is a house built on the property with a large corner overhanging the fishpond, which shelters Lucas Spring from the strong trade winds common to the area (Figure 13).

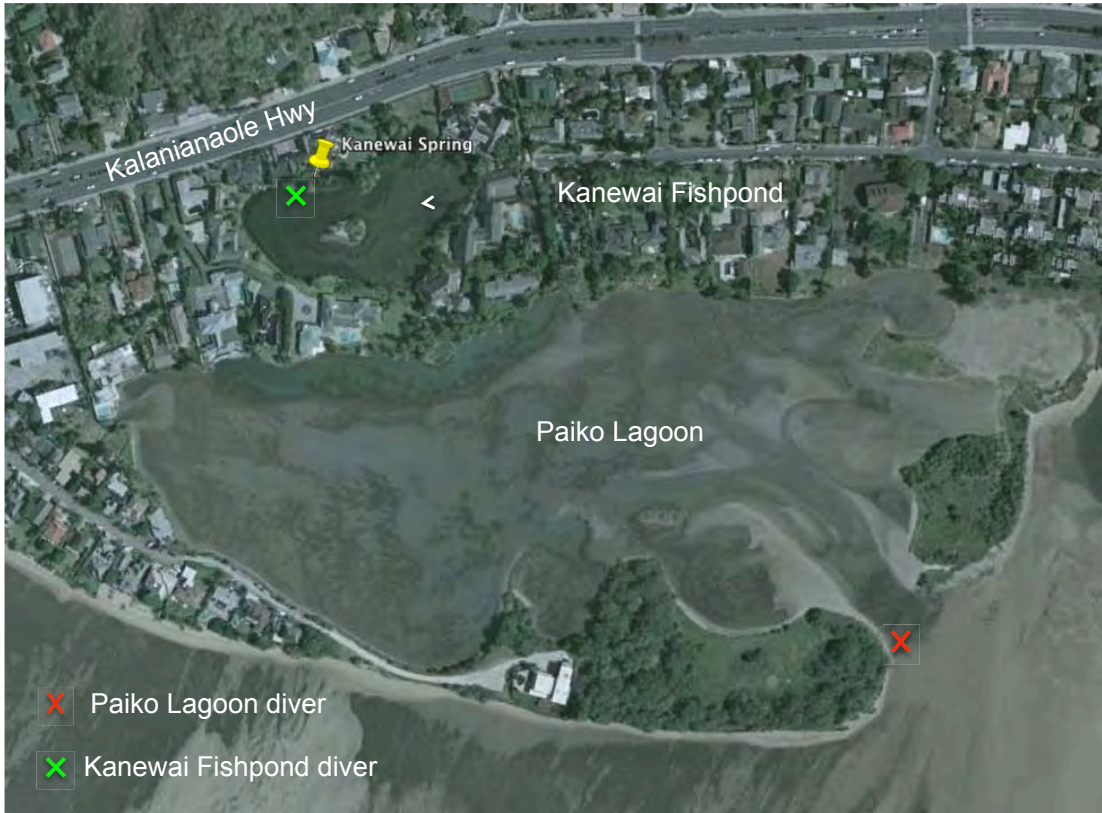
Figure 14. Overview of Kanewai Spring, Kanewai Fishpond, and Paiko lagoon with CTD-Diver locations shown with an X, Google Earth, 2010.

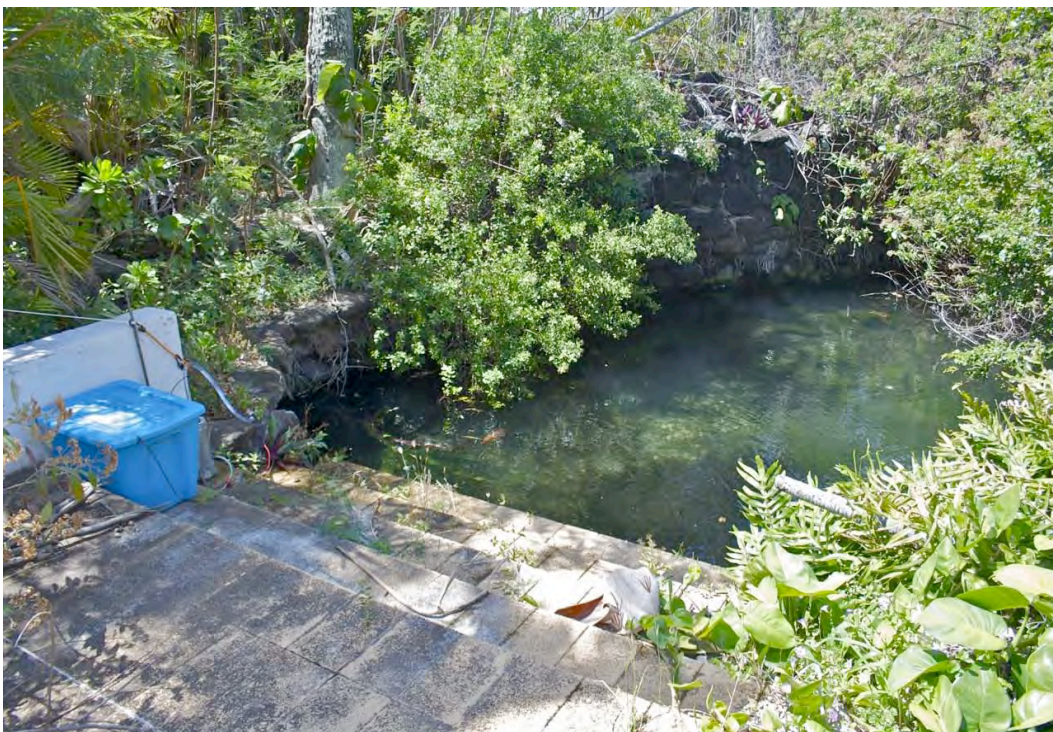
Figure 15. Kanewai Spring, April 2010. Photo: J. Kennedy.

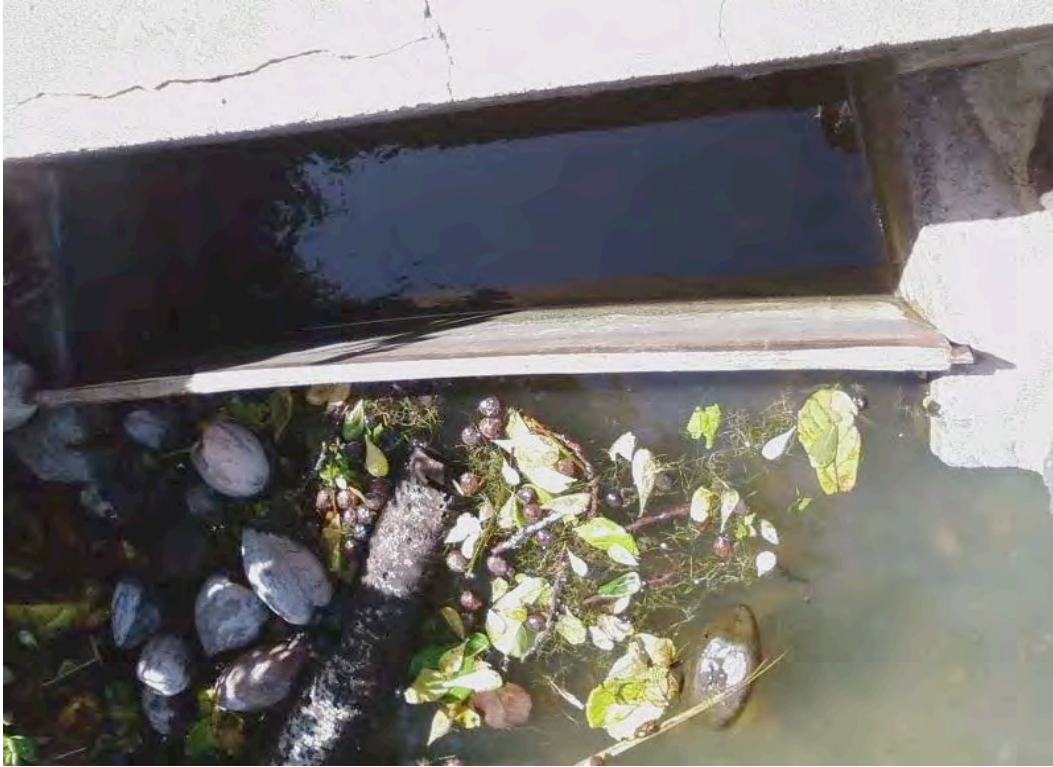
Figure 16. Plywood barrier separating Kanewai Fishpond (bottom) from Paiko Lagoon (top). Photo: J Kennedy.

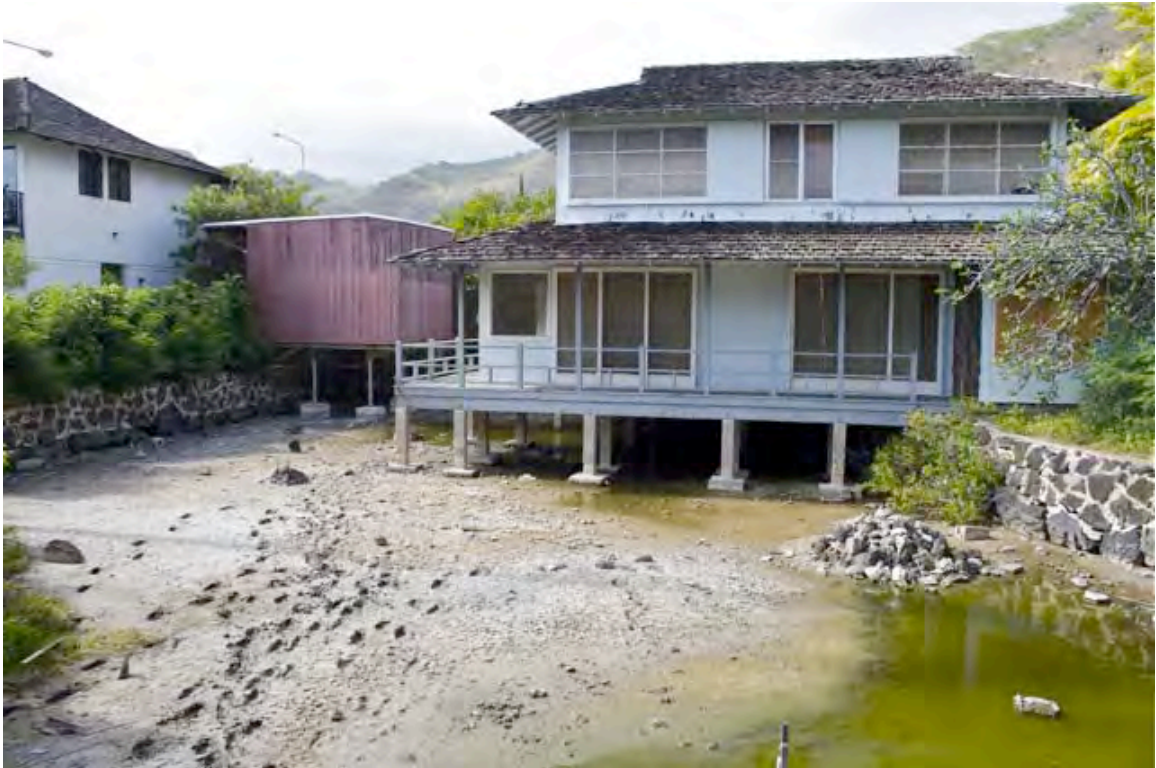
Figure 33. Lucas Spring, April 2010. Photo: J. Kennedy.

The water volume of Lucas Spring changed dramatically throughout the entire research period of April 2010 to April 2011. Lucas Spring had an initial water volume of 7.7 m^3 during the April 2010 deployment, with only one fourth of the surface area covered with water, the remainder being desiccated to mud (Figure 33). Prior to the August deployment at Lucas Spring, the *`auwai* leading to the ocean had been partially dug out, allowing ocean water into Lucas Spring during some high tide events (Figure 34). The August deployment thus showed a dramatic change in water level with an estimated water volume of 64 m^3 , covering all previous muddy areas of Lucas Spring. The increased salinity of the August deployment (~ 26 vs. ~ 20 in April, see Figure 19 and Figure 20), the visual observation of the *`auwai*, and the fact that the August radon inventories were of the same order of magnitude as those in April (150 and 350 dpm/m^2 ,

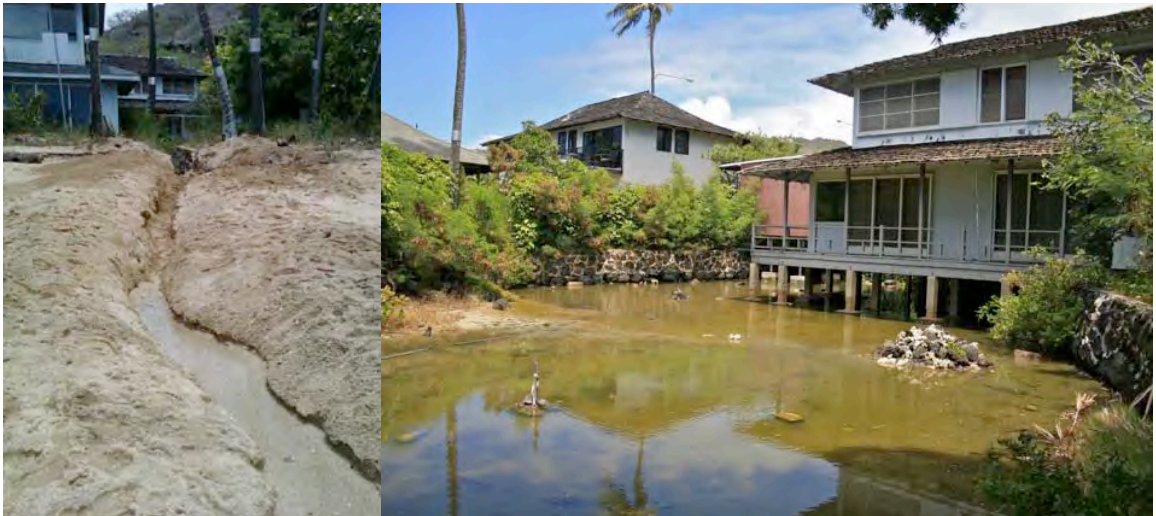
Figure 34. Lucas Spring *`auwai* after being dug out (Photo: C. Cramer) and Lucas Spring July deployment Photo: J. Kennedy.

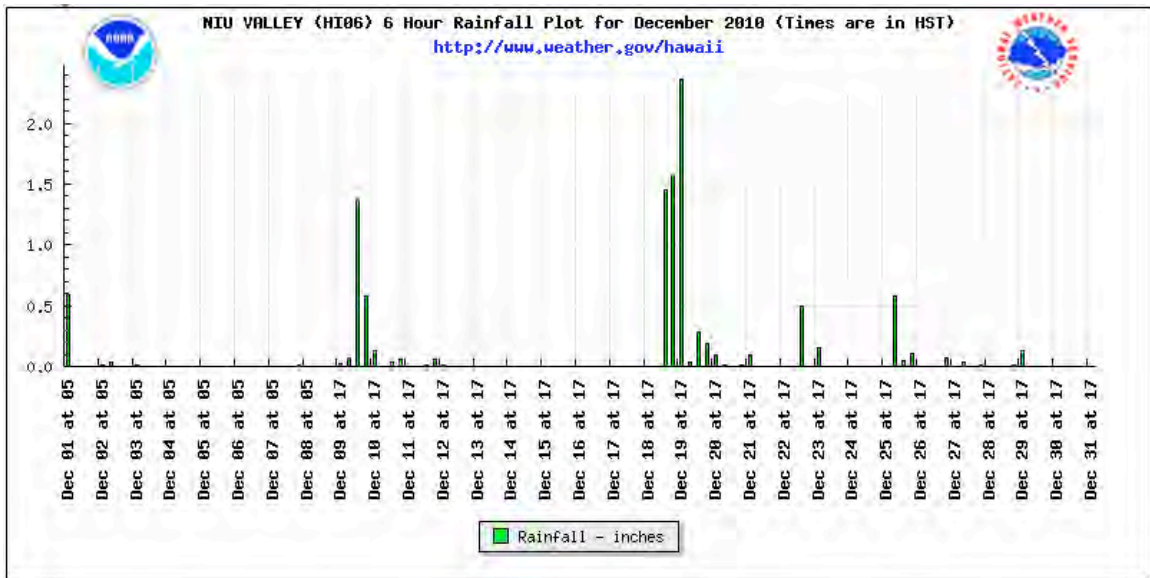
Figure 35. Niu Valley rain gauge 6-hour rainfall plot for December 2010 (www.weather.gov/hawaii).

The next precipitation event took place on December 10, with a 12-hour rainfall total of ~50 mm (Figure 35); one day later a small spike in water level was observed at Lucas Spring. The one-day lag suggested that it was increased hydraulic head and not surface water runoff that impacted Lucas Spring. Interestingly, only a very small drop in salinity (0.3) was observed with the December 10 precipitation event, though the small salinity fluctuations prior to this event diminished greatly, suggesting that the precipitation and corresponding increase in hydraulic head overrode any tidally induced impacts of ocean water on the coastal aquifer at Lucas Spring.

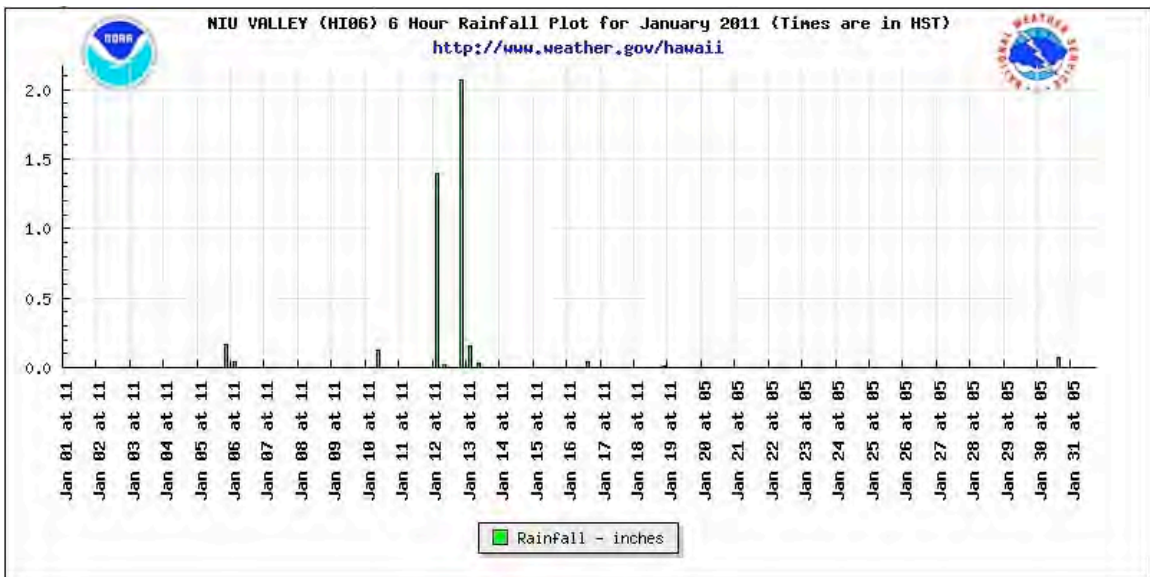
Figure 36. Niu Valley rain gauge 6-hour rainfall plot for January 2011 (www.weather.gov/Hawai'i).

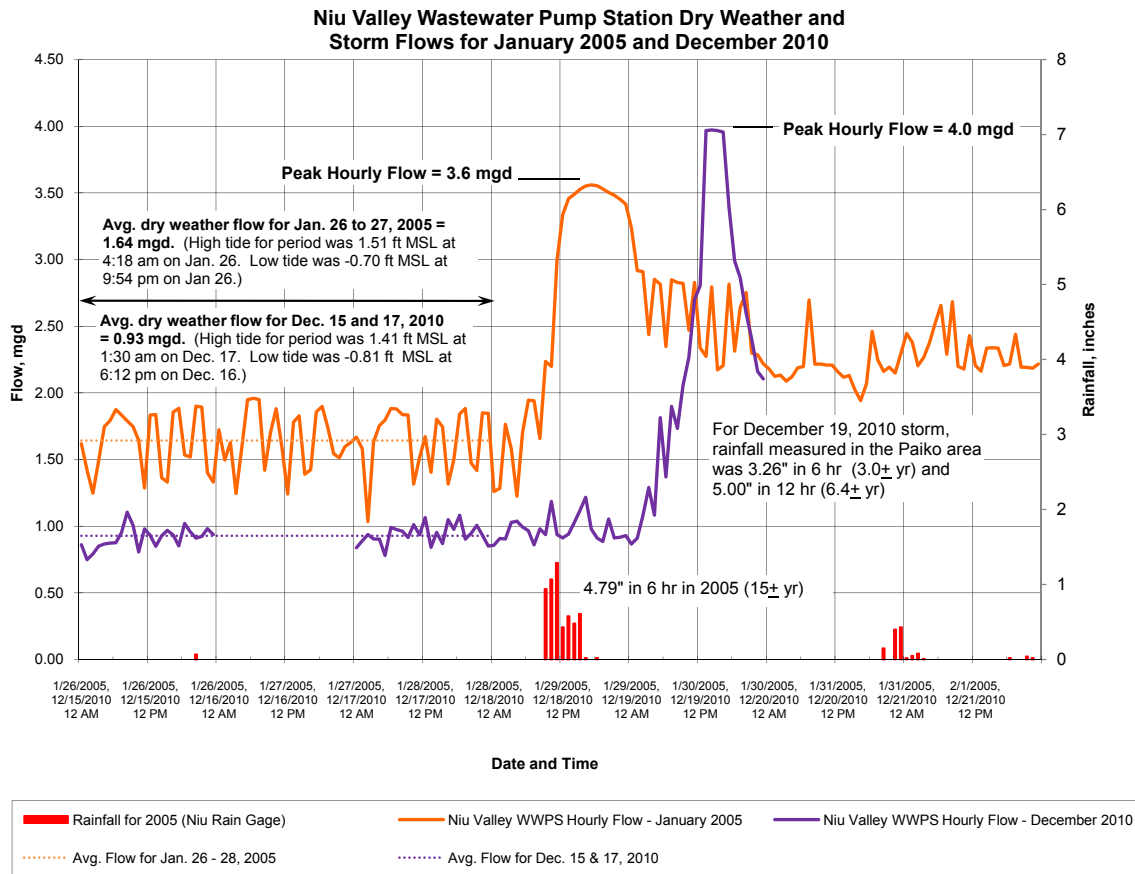
Figure 37. Dry-weather flow rates from the Niu Valley Wastewater Pump Station, showing flow rates from January 2005 and December 2010 (Abe, HDR Inc.).

for the Niu Valley wastewater pump station. Figure 37 shows two dry-weather flow rates within the sewer system, with the January 2005 representative of the pre-rehabilitation scenario and the December 2010 flow rate showing the flow rate after the rehabilitation project was complete. The data reveals about a $2650 \text{ m}^3 \text{ day}^{-1}$ decrease in the flow rate after the sewer line rehabilitation project was completed. This data reveals that about 70% of the estimated $3,780 \text{ m}^3 \text{ day}^{-1}$ of groundwater is no longer infiltrating into the sewer line. All of the data suggests that the sewer line rehabilitation project did indeed restore some groundwater flow to the subterranean aquifer conduits, some of which feed Lucas Spring. Because only 4% of the restored flow of $2650 \text{ m}^3 \text{ day}^{-1}$ in Lucas Spring was accounted for, the rehabilitation project probably also enhanced groundwater discharge to the coastline or other nearby springs.
